DG-09

BATHYMETRIC MONITORING DATA

Figure 1
Bathymetric Contours and
Locations of the Staff Gauge
and Permanent Benchmark
at Pond DG-09
Douglas County, NE
Metropolitan Utilities District

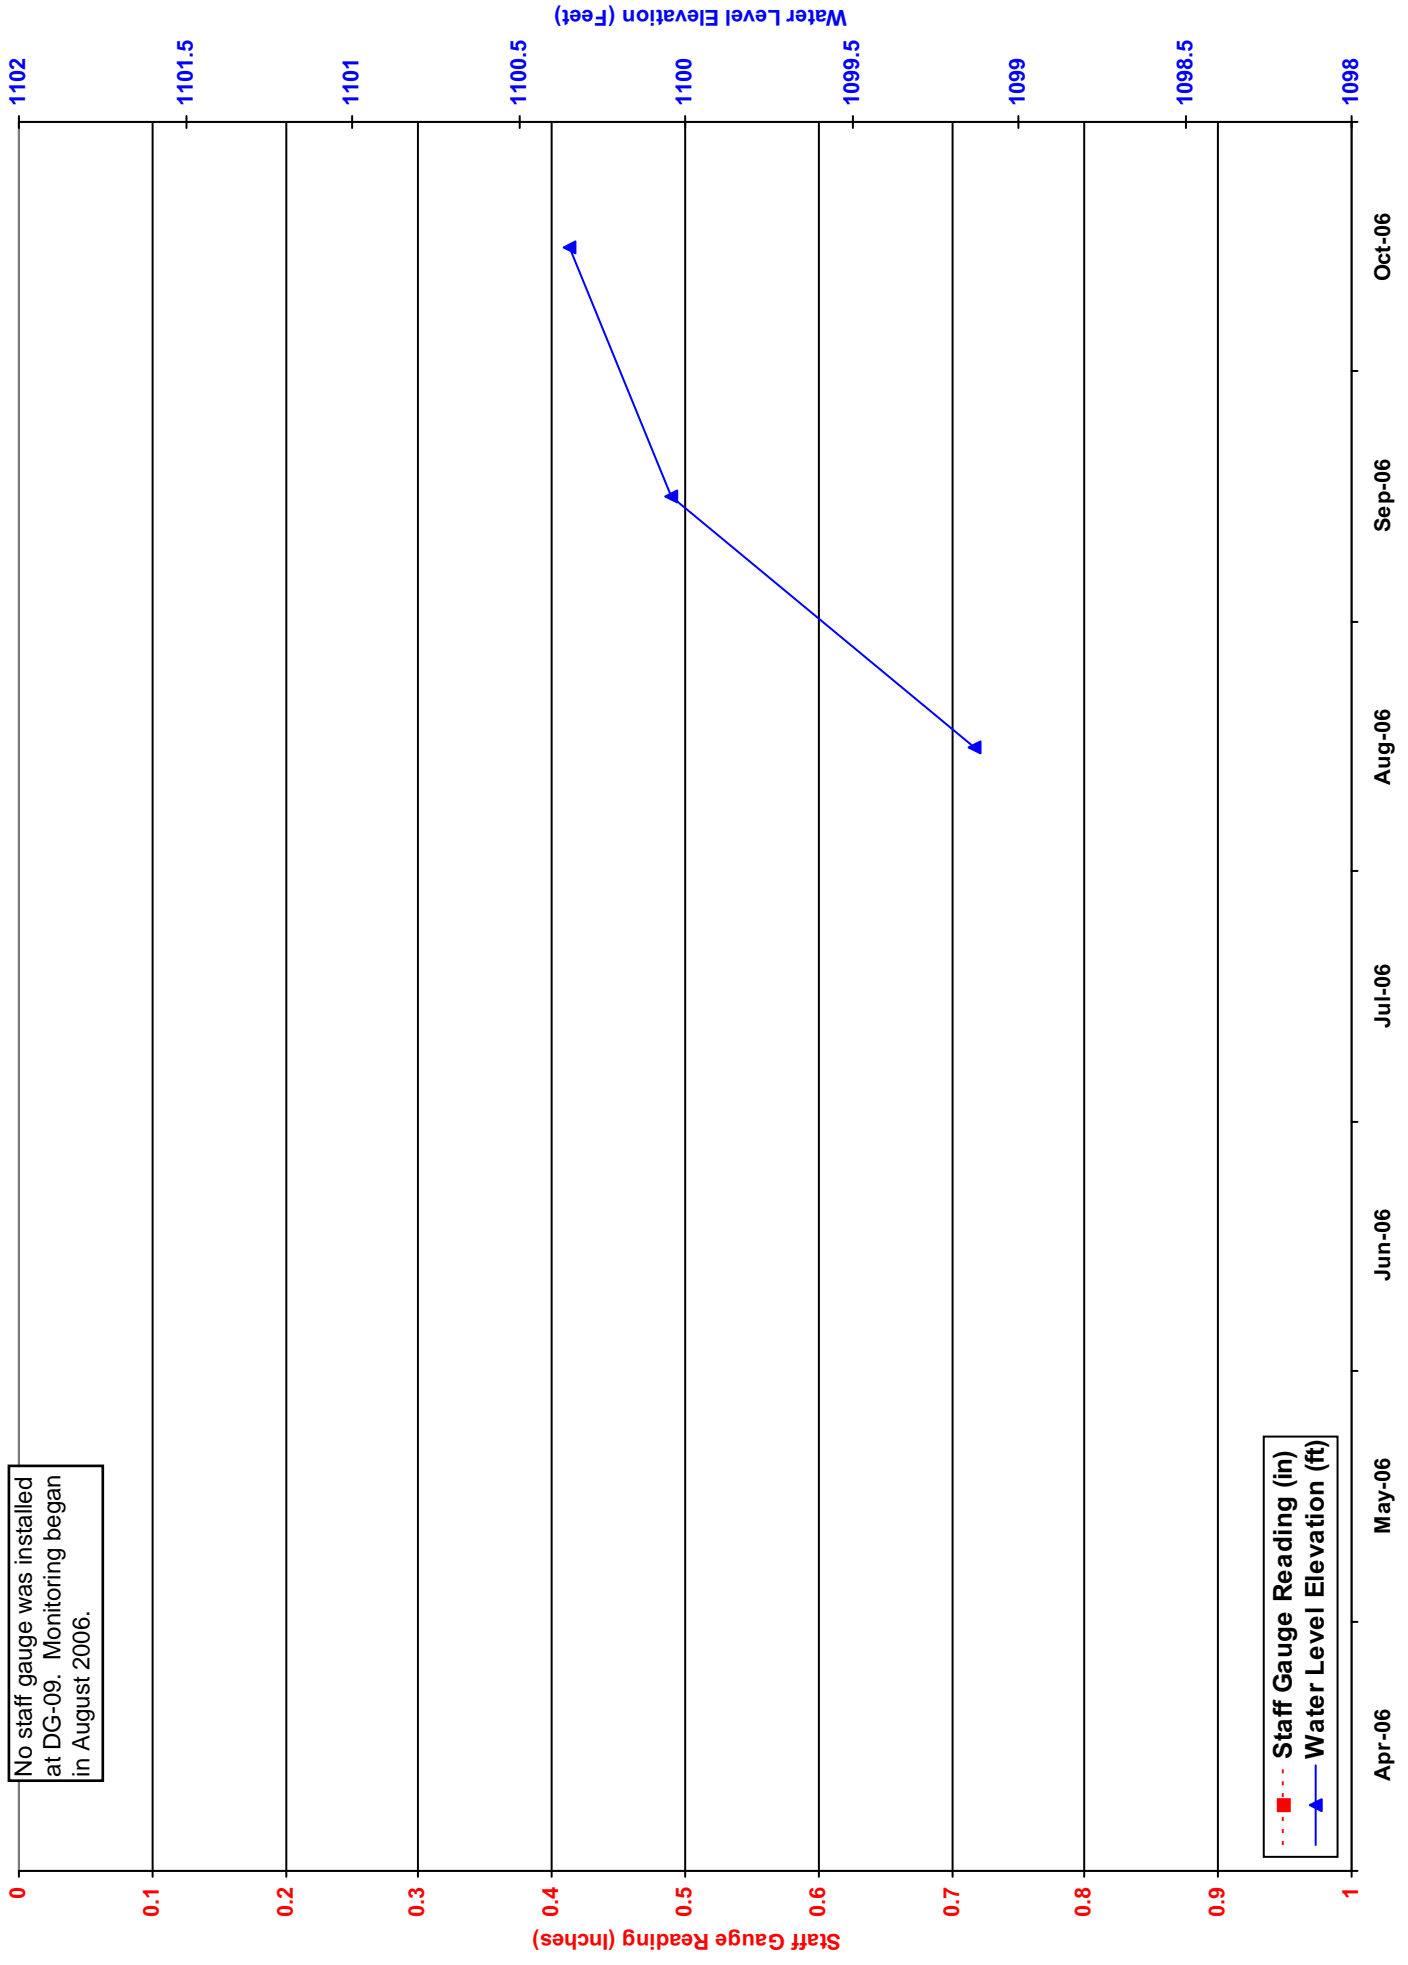
Figure 2 2006 Water Level Elevations for PondDG-09

No staff gauge was installed at DG-09. Monitoring began in August 2006.

.....■ Staff Gauge Reading (in)
———▲ Water Level Elevation (ft)

<u>Date</u>	<u>Staff Gauge Reading (inches)</u>	<u>Water Level Elevation (feet)</u>
8/14/2006		1,099.13
9/19/2006		1,100.04
10/17/2006		1,100.35
